Technical Memorandum and Inspection Report

Date:	February 24, 2009
To:	Village of Sugar Grove – Public Works Department
From:	Trotter and Associates Inc.
Subject:	Mallard Point Stormwater Management

This correspondence is intended to serve as a technical memorandum and inspection report for the stormwater improvements located adjacent to the stormwater management facilities within the Mallard Point Development.

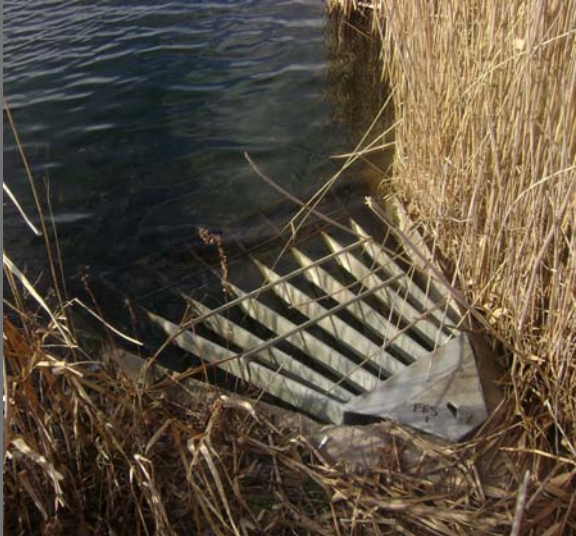
1. Flared End Section #31

Structure Number	FES 31 TAI # 1	Source Information Mallard Point Units II & IV As-built Drawings Sheet 2 Mallard Point Units II & IV As-Built Drawing Sheet 7
Type of Structure	Flared End Section w/ Grate

Size	36" Diameter	
Proposed Elevation	Flow Line 668.00	
Recorded Elevation	Flow Line 668.23	
Condition:	<ul style="list-style-type: none"> • Concrete and Grate are in good condition and there is less than 3" of Silt • Surrounded by vegetation • Rip rap that is commonly installed was not found.

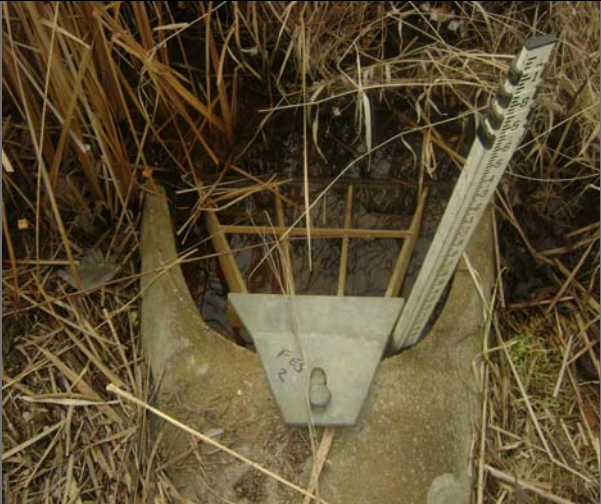
2. Flared End Section #26B

Structure Number	FES 26B TAI #2	Source Information Mallard Point Units II & IV As-built Drawings Sheet 2 Mallard Point Units II & IV As-built Drawings Sheet 7 (labeled as 26A on sheet 7)
Type of Structure	Flared End Section w/ Grate

Size	18" Diameter	
Proposed Elevation	Flow Line 668.00	
Recorded Elevation	Flow Line 669.60	
Condition:	<ul style="list-style-type: none"> • Concrete and Grate are in good condition and there is less than 2" of Silt w/in FES • Surrounded by vegetation including encroachment into structure • Rip rap that is commonly installed was not found.

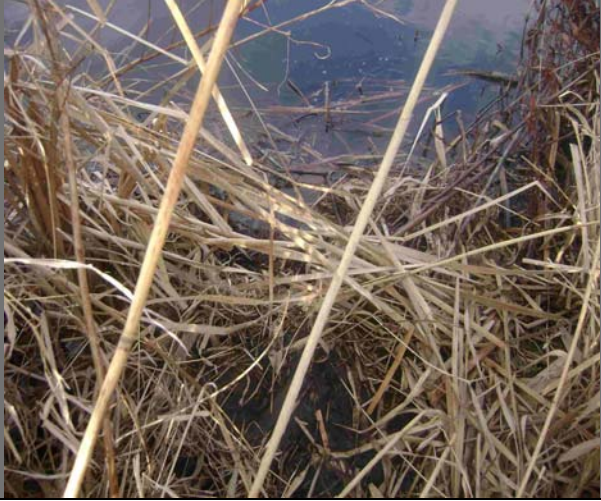
3. Flared End Section 34A

Structure Number	FES 34A TAI #4	Source Information Mallard Point Units II & IV Final Engineering Sheet 18 Mallard Point Units II & IV As-Built Drawing Sheet 2
Type of Structure	Flared End Section w/ Grate

Size	30" Diameter	
Proposed Elevation	Flow Line 668.00	
Recorded Elevation	Flow Line 667.81	
Condition:	<ul style="list-style-type: none">• Measured as 27" Diameter• Structure was buried and difficult to find• Surrounded by vegetation including encroachment into structure• Rip rap that is commonly installed was not found

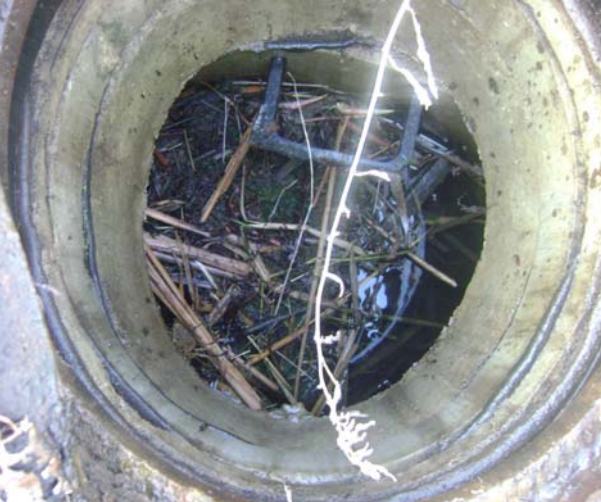
4. Manhole #34

Structure Number	MH 34 TAI #4A	Source Information Mallard Point Units II & IV Final Engineering Sheet 18 Mallard Point Units II & IV As-Built Drawing Sheet 2
Type of Structure	Type C Manhole with Type 1 Frame and Closed Lid

Size	48" Dia	
Proposed Elevation	Rim-NA Inv- 668.00 8" Restrictor Inv- 668.00 Interior Dividing wall – 669.85	
Recorded Elevation	Rim-672.83 Inv- 8" Restrictor Inv-	
Condition:	<ul style="list-style-type: none">• Structure is filled with debris and vegetation. Probing rod could only measure down 4.1' (668.73)• TAI could not verify the size of restrictor and elevation of restrictor or the installation and elevation of interior dividing wall

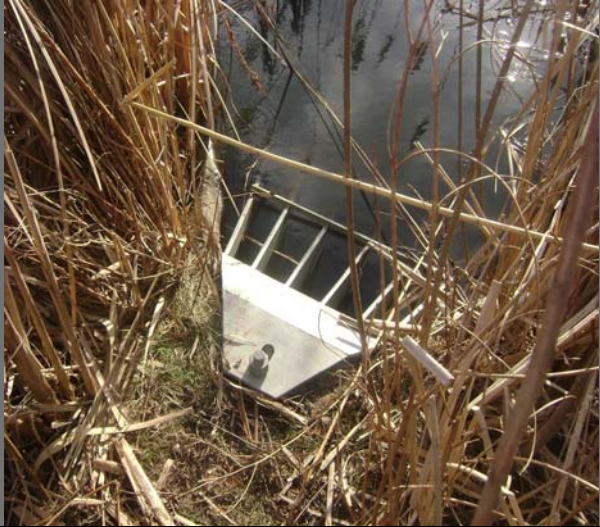
5. Flared End Section #34 B

Structure Number	FES 34B TAI #34	Source Information Mallard Point Units II & IV Final Engineering Sheet 18 Mallard Point Units II & IV As-Built Drawing Sheet 2
Type of Structure	Flared End Section w/ Grate

Size	30" Diameter	
Proposed Elevation	Flow Line 668.00	
Recorded Elevation	Flow Line 667.85	
Condition:	<ul style="list-style-type: none">• Measured as 27" Diameter• Flared End had between 3" and 6" of silt.• Surrounded by vegetation including encroachment into structure• Rip rap that is commonly installed was not found

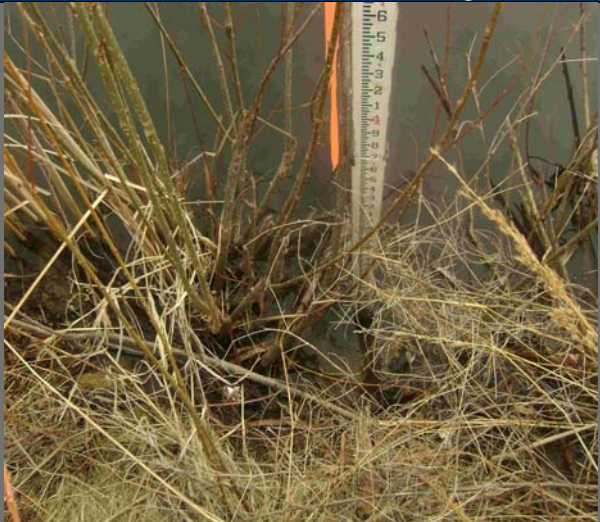
6. Flared End Section #28A

Structure Number	FES 28A TAI #6	Source Information Mallard Point Units II & IV As-built Drawings Sheet 7 Mallard Point Units II & IV As-Built Drawing Sheet 2
Type of Structure	Flared End Section w/ Grate

Size	30" Diameter	
Proposed Elevation	Flow Line 668.00 As-Built 668.47	
Recorded Elevation	Top of Pipe 669.78 Flow Line 668.53	
Condition:	<ul style="list-style-type: none">• Could only measure top of pipe• Difficult to locate• Contained between 4" and 6" of silt and could not accurately find the invert• Rip rap that is commonly installed was not found

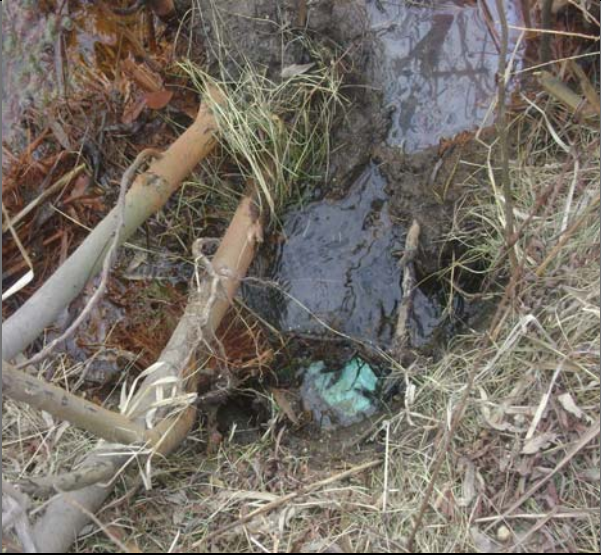
7. Field Tile at Pond- Adjacent to lift station

Structure Number	Field Tile TAI #6A	Source Information	Mallard Point Units II & IV Final Engineering Sheet 18
Type of Structure	Field Tile at Northwest Corner of Basin

Size	8" Dia		
Proposed Elevation	Flow Line NA		
Recorded Elevation	Flow Line 669.36		
Condition:	<ul style="list-style-type: none">• Measured as 8" Diameter PVC Pipe• 4" of silt at bottom of pipe• Adjacent vegetation and small diameter trees are located at outfall

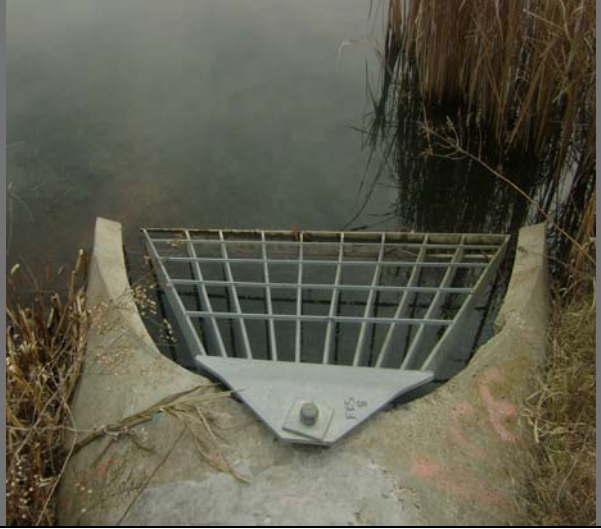
8. Flared End Section #16

Structure Number	FES 16 TAI #8	Source Information	Mallard Point Units II & IV Final Engineering Sheet 14 Mallard Point Units II & IV As-Built Drawing Sheet 2
Type of Structure	Flared End Section with Grate

Size	54" Dia		
Proposed Elevation	Flow Line- 668.00 As-Built 667.97		
Recorded Elevation	Flow Line 668.20		
Condition:	<ul style="list-style-type: none">• Concrete and grate are exposed and in good condition• 6" of silt at bottom of pipe• Adjacent vegetation to the southwest• Rip rap that is commonly installed was not found

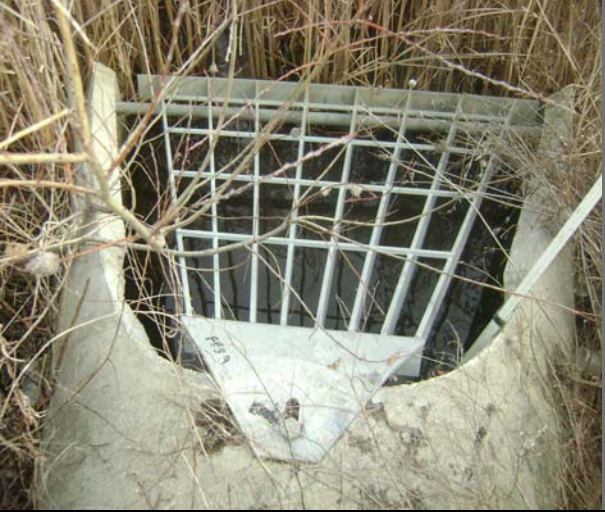
9. Flared End Section Y2

Structure Number		Source Information
FES Y2 TAI #9		Rolling Oaks As-Built Plans Sheet C.3.4
Type of Structure

Size		
Proposed Elevation		
Recorded Elevation		
Flow Line- 669.18 As-Built 669.28		
Flow Line 669.37		
Condition:		
<ul style="list-style-type: none">• Concrete and grate are exposed and in good condition• No silt at bottom• Adjacent vegetation to the southwest• Rip rap that is commonly installed was not found

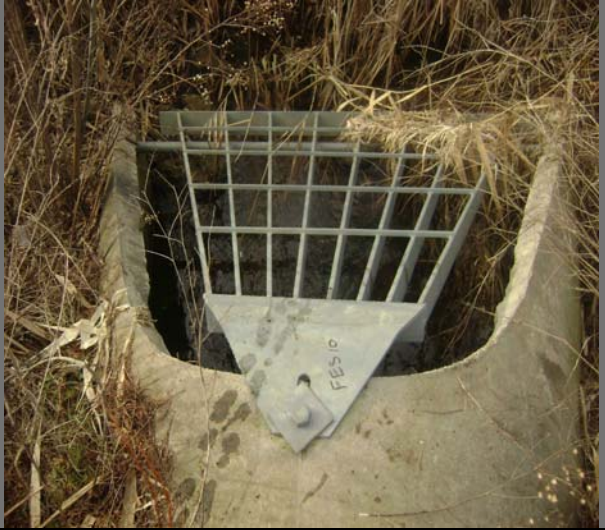
10. Flared End Section Y1

Structure Number		Source Information
FES Y1 TAI #10		Rolling Oaks As-Built Plans Sheet C.3.4
Type of Structure

Size		
Proposed Elevation		
Recorded Elevation		
Flow Line- 669.50 As-Built 669.47		
Flow Line 669.59		
Condition:		
<ul style="list-style-type: none">• Concrete and grate are exposed and in good condition• Less than 3" of silt at structure• Vegetation surrounding entire structure• Rip rap that commonly is installed was not found

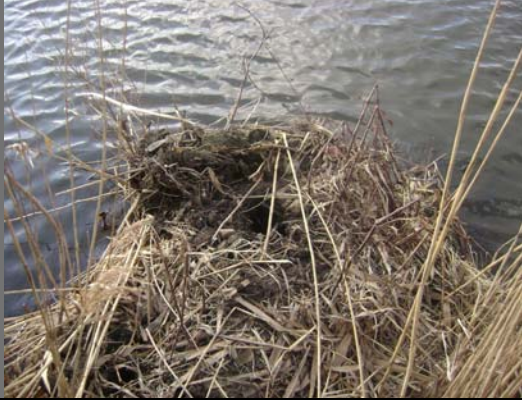
11. Flared End Section #32

Structure Number	FES 32 TAI #11	Source Information Mallard Point Units II & IV Final Engineering Sht. 18 Mallard Point Units II & IV As-Built Drawing Sht. 2
Type of Structure	Flared End Section w/ Grate

Size	30" Diameter	
Proposed Elevation	Flow Line 668.00	
Recorded Elevation	Flow Line 668.07	
Condition:	<ul style="list-style-type: none"> • Measured as 27" Diameter • Structure was buried even though it protrudes into open water by four feet. • Vegetation and silt are blocking structure and limiting flow • Water surface observed to be 669.93 during inspection • Elevation should be verified when structure is clean • Rip rap that is commonly installed was not found.

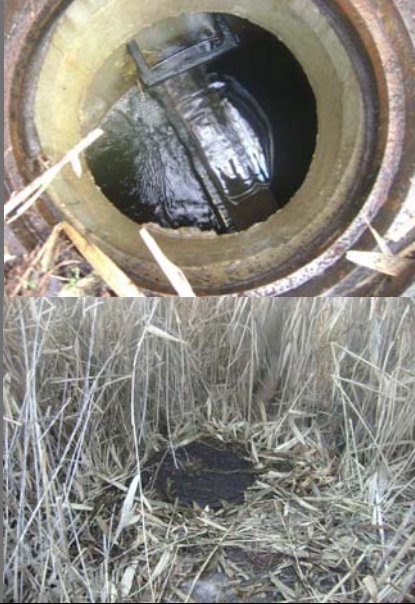
12. Manhole #32A

Structure Number	MH 32A TAI #11A	Source Information Mallard Point Units II & IV Final Engineering Sheet 18 Mallard Point Units II & IV As-Built Drawing Sheet 2
Type of Structure	Type C Manhole with Type 1 Frame and Closed Lid

Size	60" Dia	
Proposed Elevation	Rim-673.00 Inv- 668.00 8" Restrictor Inv- 668.00 Interior Dividing wall – 669.85	
Recorded Elevation	Rim-672.99 Bottom of Structure - 667.64 Interior Dividing Wall – 669.84	
Condition:	<ul style="list-style-type: none"> • Structure was buried and found with metal detector. The bottom photo indicates the structure after it was cleared. • Adjacent 4" diameter tree is growing within 6" structure • Structure is filled with water and vegetation. • Water is spilling over interior dividing wall • TAI could not verify size and elevation of restrictor

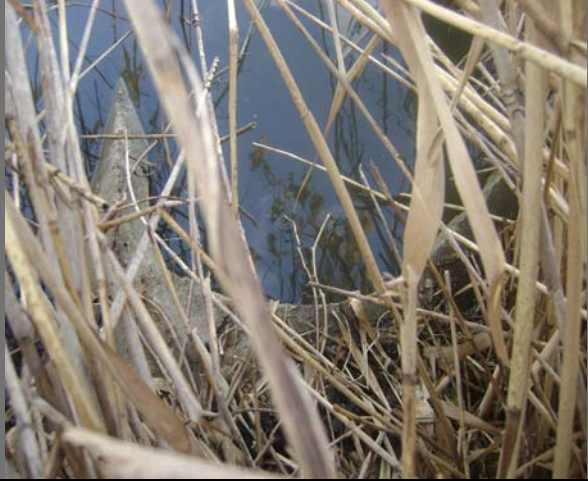
13. Flared End Section #33

Structure Number		Source Information
FES 33 TAI #12		Mallard Point Units II & IV Final Engineering Sheet 18 Mallard Point Units II & IV As-Built Drawing Sheet 2
Type of Structure	Flared End Section w/ Grate

Size	30" Diameter	
Proposed Elevation	Flow Line 668.00	
Recorded Elevation	Flow Line 668.17	
Condition:	<ul style="list-style-type: none">• Measured as 27" Diameter• Structure was found with metal detector• No grate is installed• Structure elevation should be verified after it has been cleared• Using elevations during inspection there appears to be backpitch to the north• Rip rap that is commonly installed was not found

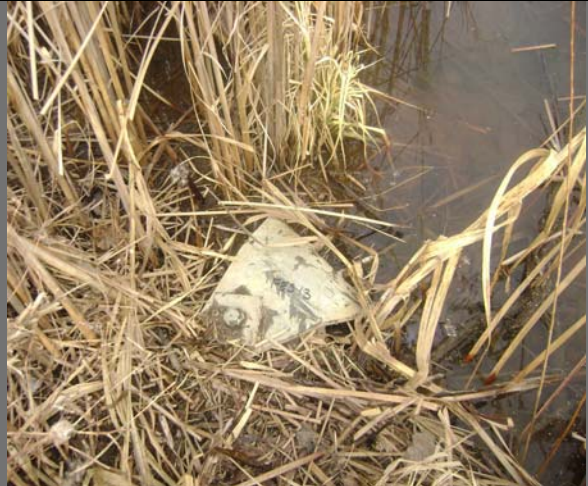
14. Flared End Section S

Structure Number		Source Information
FES S TAI #13		Rolling Oaks As-Built Plans Sheet C.3.4
Type of Structure	Flared End Section with Grate

Size	12" Dia	
Proposed Elevation	Flow Line- 668.00 (To be installed at NWL) As-Built 668.88	
Recorded Elevation	Flow Line 669.03	
Condition:	<ul style="list-style-type: none">• Structure has 8" of silt• Structure is overgrown with vegetation• Water surface elevation is 10" above the flow line of the structure• Rip rap that is commonly installed was not found

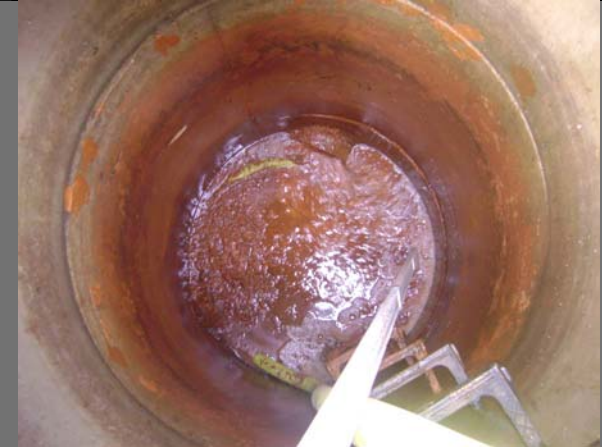
15. No Number - TAI Structure # 13A

Structure Number	No Number It is located within Unit III TAI #13A	Source Information	Does not appear on plans. Structure was likely used in an attempt to reroute a field tile
Type of Structure	MH Type A with Type I Frame and Closed Lid

Size	48" Dia		
Proposed Elevation	NA		
Recorded Elevation	Rim-675.94 Inv-664.84 N- 15" VCP Inv-664.74 SW- 8" Mat-?		
Condition:	<ul style="list-style-type: none">• Structure is located adjacent to the pond within Unit III. It appears to have field tiles tied into the structure• Village crews assisted in pumping out of structure. Water was drawn down but it could not be completely pumped out. Reddish iron sludge material was removed however the material did not contain any noticeable odor

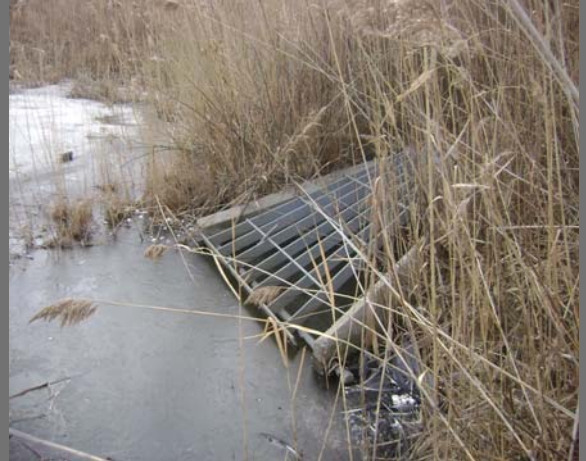
16. Flared End Section A

Structure Number	FES A TAI #14	Source Information	Rolling Oaks As-Built Plans Sheet C.3.4
Type of Structure	Flared End Section with Grate

Size	36" Dia		
Proposed Elevation	Flow Line- 668.00 (To be installed at NWL) As-Built 670.37		
Recorded Elevation	Flow Line 669.09		
Condition:	<ul style="list-style-type: none">• Structure is overgrown with vegetation• Rip rap that is commonly installed was not found• Concrete and grate are in good condition• Structure has 1" or less of silt in the bottom

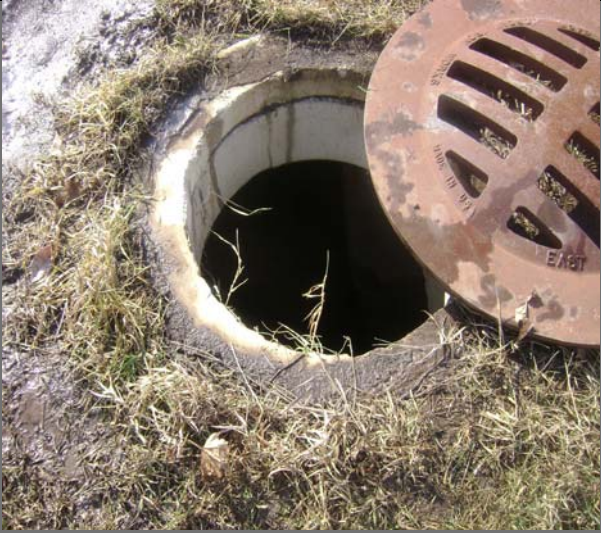
17. Catch Basin #10A

Structure Number	CB 10A TAI #15	Source Information Rolling Oaks As-Built Plans Sheet C.3.4
Type of Structure	Type C Manhole with Neenah 4340-B

Size	60" Dia	
Proposed Elevation	Rim-678.44 Inv- 670.38 E Inv- 674.10 W Inv- 669.88 S As Built Rim-679.57 Inv- 670.83 E Inv- 674.61 W Inv- 670.77 S	
Recorded Elevation	Rim-679.61 Inv- 671.81 E Inv- 675.11 W Inv- 671.11 S	
Condition:	<ul style="list-style-type: none">• Structure has 3" of silt at bottom

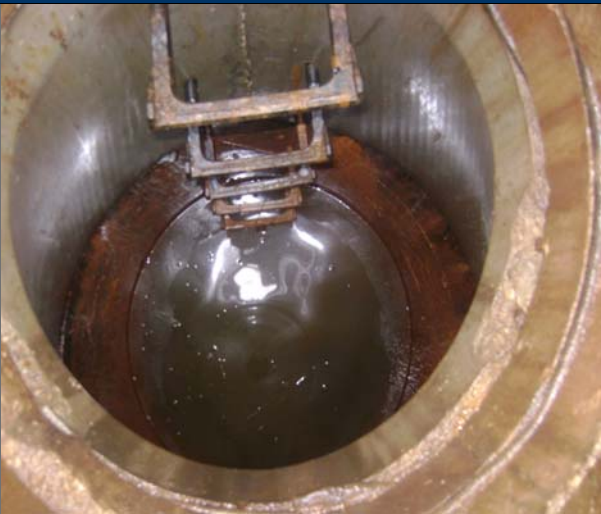
18. No Number - TAI Structure #16

Structure Number	No Number "Identified as Install Cleanout" TAI #16	Source Information Rolling Oaks As-Built Plans Sheet C.3.4
Type of Structure	Type C Manhole with Neenah 4340-B

Size	48" Dia	
Proposed Elevation	Rim-677.24 Inv- 669.63 N As Built Rim-677.15 Inv- 670.44 N	
Recorded Elevation	Rim-676.42 Bottom of Structure - 664.22	
Condition:	<ul style="list-style-type: none">• Structure has 4" of silt at bottom

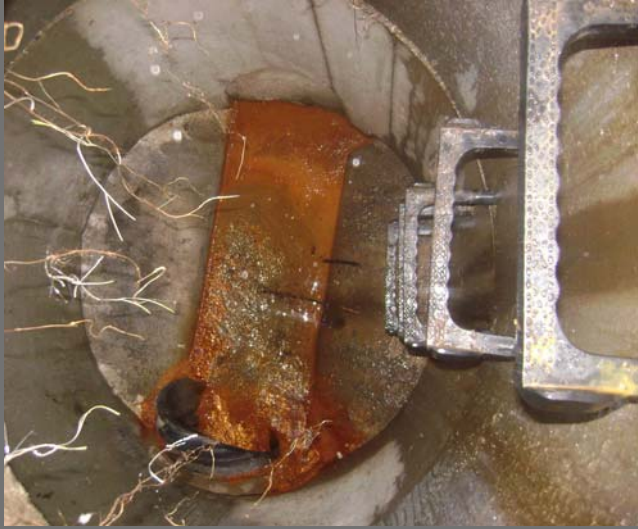
19. No Number - TAI Structure # 17

Structure Number	No Number TAI Structure # 17	Source Information Does not appear on plans. Structure was likely used in an attempt to reroute a field tile
Type of Structure	MH Type A with Type I Frame and Closed Lid

Size	48" Dia	
Proposed Elevation	NA	
Recorded Elevation	Rim-675.86 Inv- 668.46 N- Plugged Inv- 668.46 S- 15" ADS	
Condition:	<ul style="list-style-type: none">• Structure has inflow from the pipe seal grouting at the south pipe.• After discharge location has been determined it may be necessary to seal the manhole to remove inflow

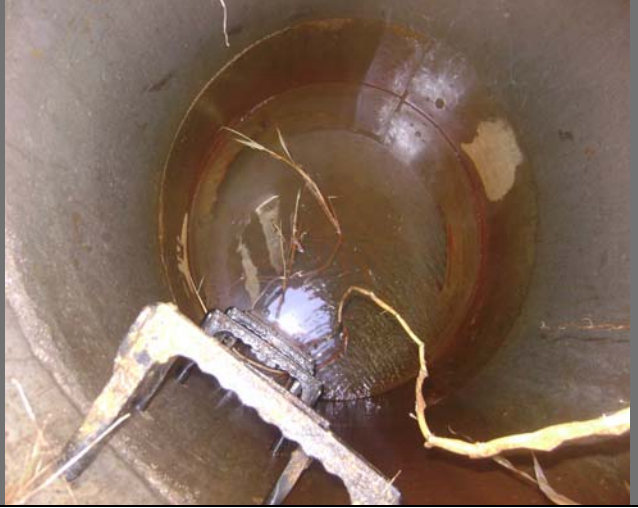
20. No Number - TAI Structure #18

Structure Number	No Number TAI Structure #18	Source Information Does not appear on plans. Structure was likely used in an attempt to reroute a field tile
Type of Structure	MH Type A with Type I Frame and Closed Lid

Size	48" Dia	
Proposed Elevation	NA	
Recorded Elevation	Rim-673.71 Inv-663.71 NW- 15" CMP Inv-663.71 S- 15" CMP	
Condition:	<ul style="list-style-type: none">• Structure has inflow at an elevation of 667.41

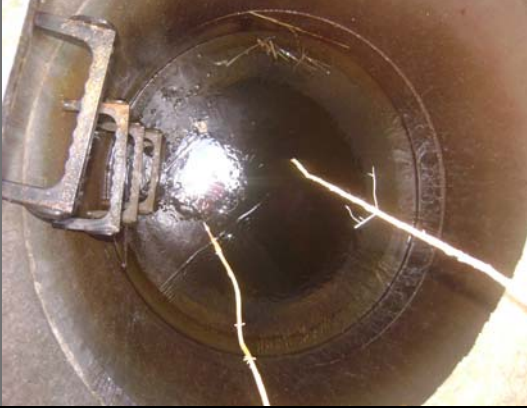
21. No Number - TAI Structure #19

Structure Number	No Number TAI Structure #19	Source Information Does not appear on plans. Structure was likely used in an attempt to reroute a field tile
Type of Structure	MH Type A with Type I Frame and Closed Lid

Size	48" Dia	
Proposed Elevation	NA	
Recorded Elevation	Rim-671.29 Inv-662.09 SW- 18" Mat-? Inv-662.09 SE- 15" Mat-? Inv-662.29 SE- 24" Mat-?	
Condition:	<ul style="list-style-type: none">• Structure water within the structure to an elevation of 664.79• Village crews assisted in pumping out of structure. It is most likely hydraulically connected to the retention facility or a field tile. Using both a 2" and 3" diameter pump the water level in the structure could not be lowered more than 0.70' or 664.09

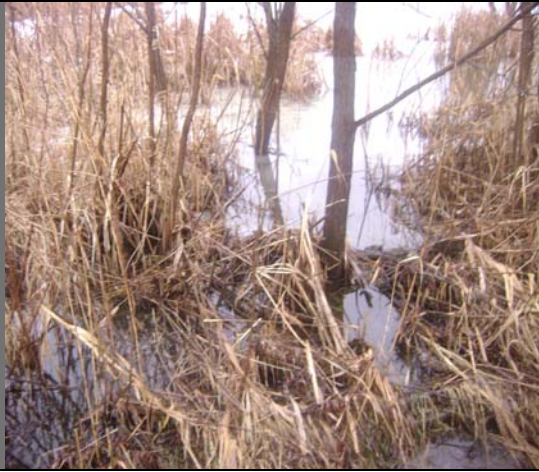
22. Flared End Section #35

Structure Number	FES 35 TAI Structure # 20	Source Information Mallard Point Units II & IV Final Engineering Sheet 19
Type of Structure	Flared End Section with Grate

Size	21" Dia	
Proposed Elevation	Flow Line- 666.75	
Recorded Elevation	Top of Pipe -669.03 Flow Line - 667.07	
Condition:	<ul style="list-style-type: none">• There is a memo from P and D modifying the location 37.0' East with revised elevation of 668.75. It is unclear as to the location at where this is measured.• Structure was only found through use of metal detector• Flow is limited to very top of pipe and to an opening approximately 6" in diameter• Trees are in close proximity to the surrounding the FES• Rip rap that is commonly installed was not found• Downstream line appears to be clean• Water level during inspection 669.22

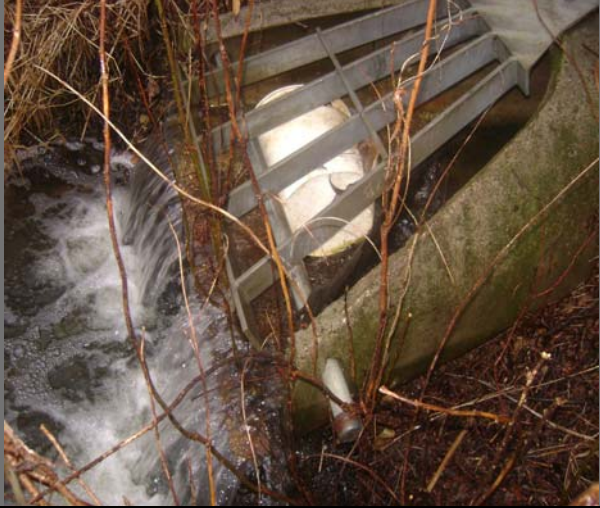
23. Flared End Section #36

Structure Number	FES 36 TAI Structure #21	Source Information	Mallard Point Units II & IV Final Engineering Sheet 19
Type of Structure	Flared End Section with Grate

Size	21" Dia		
Proposed Elevation	Flow Line- 666.50		
Recorded Elevation	Flow Line – 666.46		
Condition:	<ul style="list-style-type: none">• Structure is clean and in good condition• Water level of outfall is 665.27 during inspection• Structure is surrounded by trees and vegetation.• Bucket is located within structure• Rip rap that is commonly installed was not found

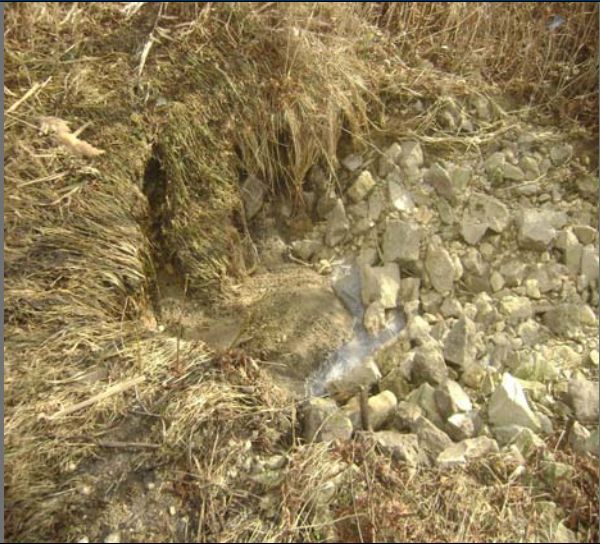
24. TAI Structure #22

Structure Number	NA TAI Structure #22	Source Information	Mallard Point Units II & IV Final Engineering Sheet 19
Type of Structure	Overflow for Wetland Retention Area

Size	20' Width		
Proposed Elevation	Overflow Elevation 669.25 Provide Rip Rap on Downstream slope		
Recorded Elevation	Overflow Elevation 669.22		
Condition:	<ul style="list-style-type: none">• This has been moved to the west side of the pipe outlet. Large diameter rip rap is present but appears to have been moved or washed out by flows. Scouring is present.• Matted vegetation is indicative of surface flows• Areas is not defined and width could not be determined

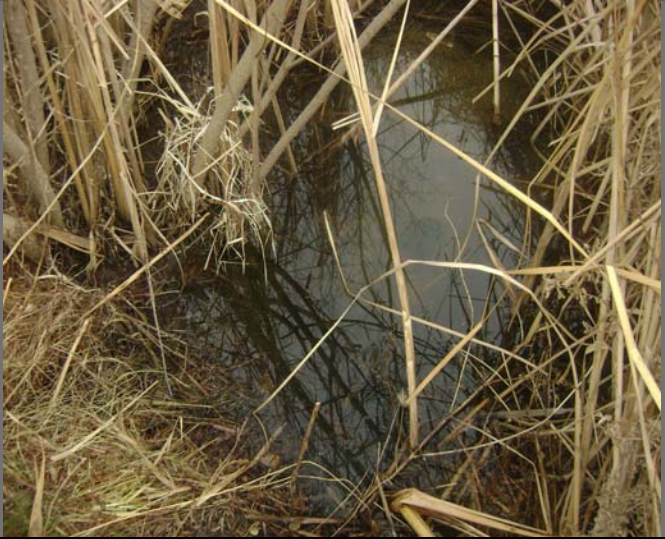
26. TAI Structure #24

Structure Number	FES EX TAI Structure #24	Source Information	Rolling Oaks As-Built Plans Sheet C.3.4
Type of Structure	Flared End Section

Size	12" Dia		
Proposed Elevation	Shown as Existing Inv 670.40		
Recorded Elevation	Top of Pipe 671.92 Flow Line 669.75		
Condition:	<ul style="list-style-type: none">Structure is overgrown with vegetationFlared End Section is not presentRip rap that is commonly installed was not foundThere is a large amount of silt at the end of the pipe

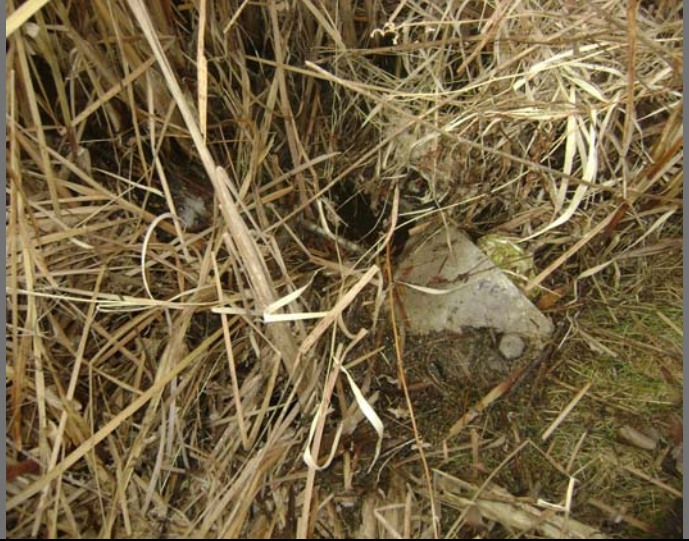
27. Flared End Section W

Structure Number		Source Information	
Structure Number	FES W TAI Structure #25	Rolling Oaks As-Built Plans Sheet C.3.4	
Type of Structure	Flared End Section w/ grate

Size	12" Dia		
Proposed Elevation	Inv 671.57		
Recorded Elevation	Top of Pipe 671.74		
Condition:	<ul style="list-style-type: none">• Structure is overgrown with vegetation• Water around pipe is approximately 2" higher due to vegetation impeding flow• Rip rap that is commonly installed was not found
